Watershed Restoration Planning and Monitoring; the Meacham Creek Example

James G. Webster
Fisheries Habitat Program

Confederated Tribes of the Umatilla Indian Reservation

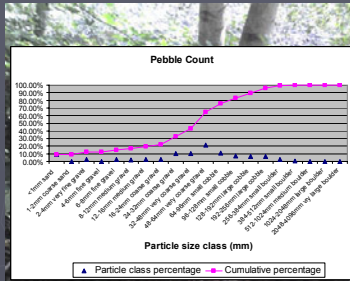
Existing Water Quality Data

- Temperature
- Sediment
 - ISCO
 - Bedload Sampling

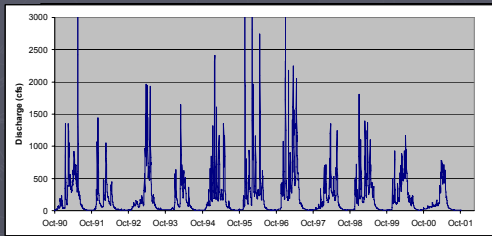
Existing Water Quality Data

- Temperature
- Sediment
- Discharge

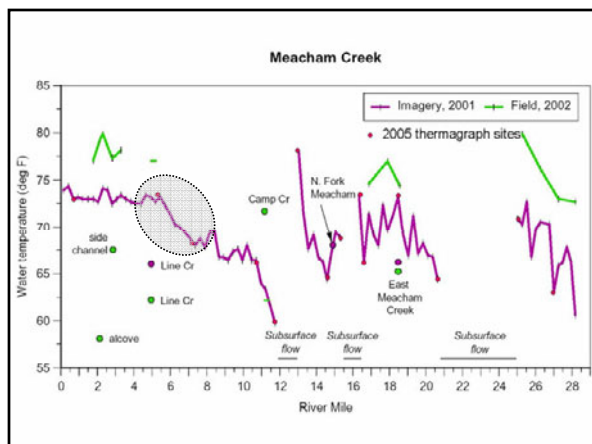
Monitoring Actions

- ▶ Temperature Monitoring
 - Longitudinal thermistors

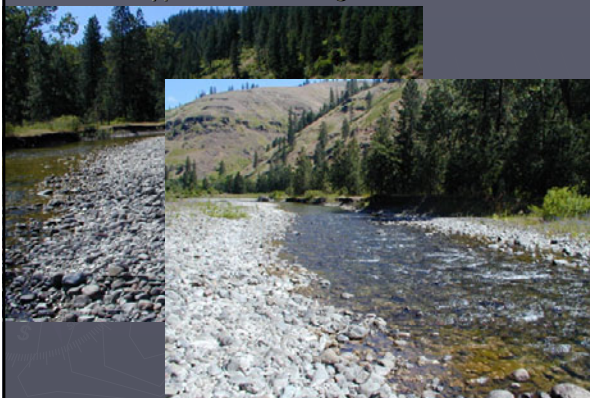
Hyporheic Investigation Sites

- Stream Temperature
- Hyporheic Flow
 - Measure of residence time
 - Evaluate flowpaths
